Voyager Bulletin

MISSION STATUS REPORT NO. 69 JUNE 20, 1985

Scan Platform Is Healthy

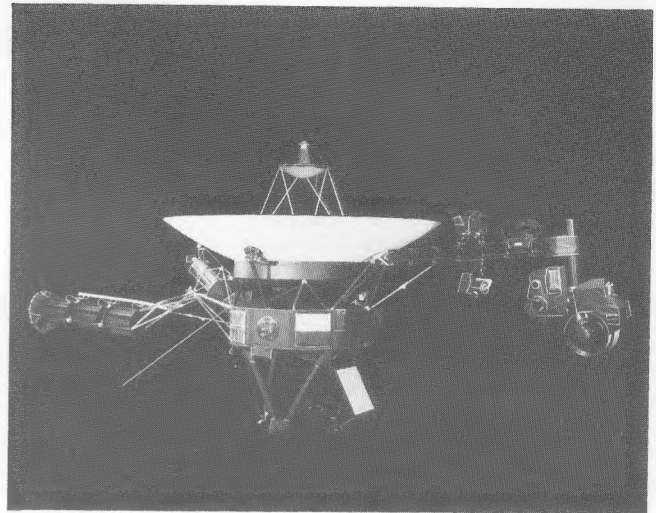
Voyager's scan platform (far right) carries the wide- and narrow-angle cameras, ultraviolet spectrometer, infrared interferometer/spectrometer, and photopolarimeter.

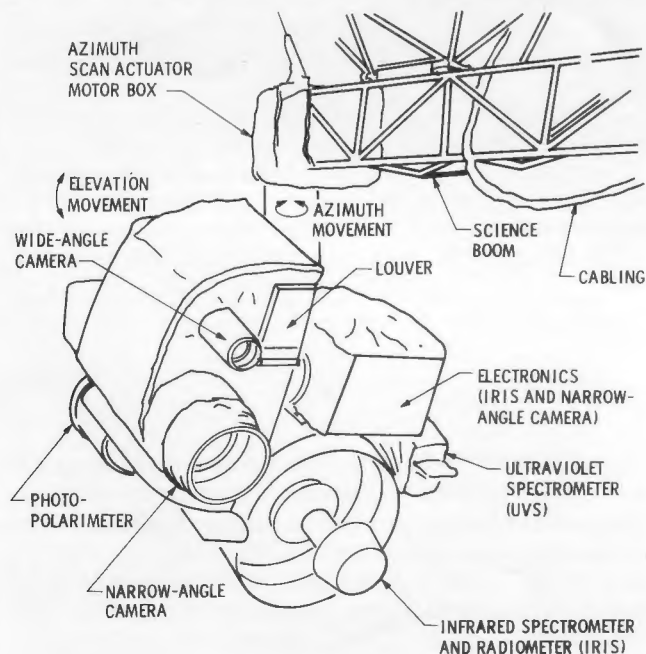
The scan platform can be rotated about two axes to provide precision pointing for its four remote sensing science instruments.
